CONNECTICUT RIVER BASIN  
SUFFIELD, CONNECTICUT

# SCHWARTZ POND DAM CT 00280

PHASE I INSPECTION REPORT  
NATIONAL DAM INSPECTION PROGRAM

APRIL 1981

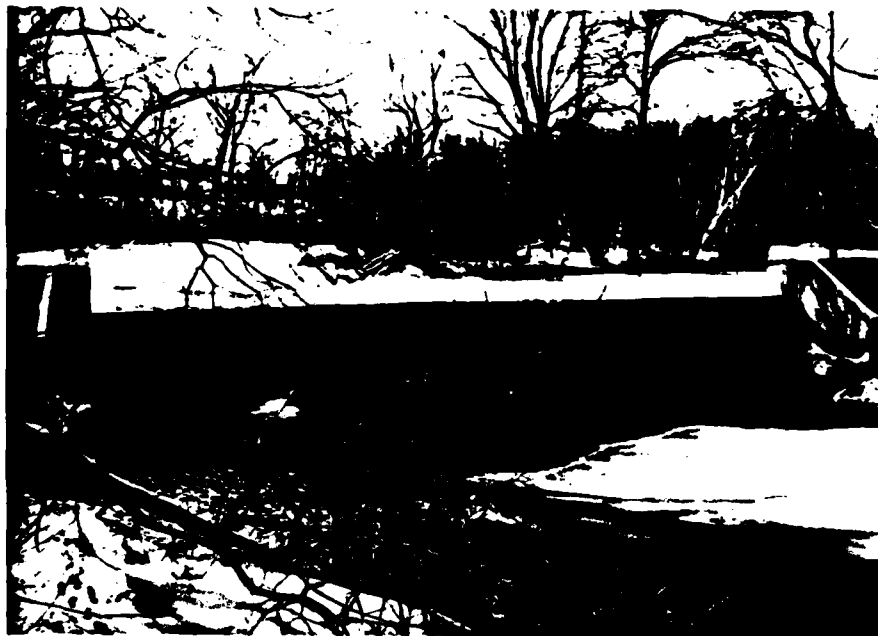
The concrete spillway was generally in good condition as shown in Photos 2 and 3. Exposed coarse aggregate along the spillway and two minor cracks on the crest were observed as noted on the general dam plan in Appendix B. Any seepage that may flow through or under the spillway could not be inspected due to the water flowing over the spillway.

Schwartz Pond, which serves as the upstream channel to the spillway, was in good condition with no accumulation of debris. A small island with a few overhanging trees was the only spillway obstruction noted (See Photo 2).

Photo 2 - View of spillway from bridge.  
Note outlet works on left edge  
of spillway.

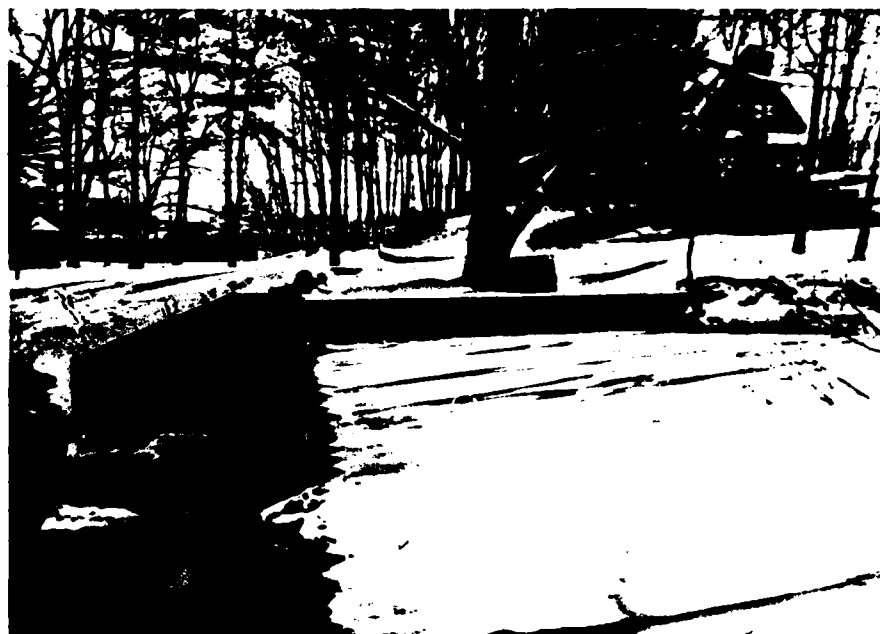
Photo 3 - View looking east across spillway.

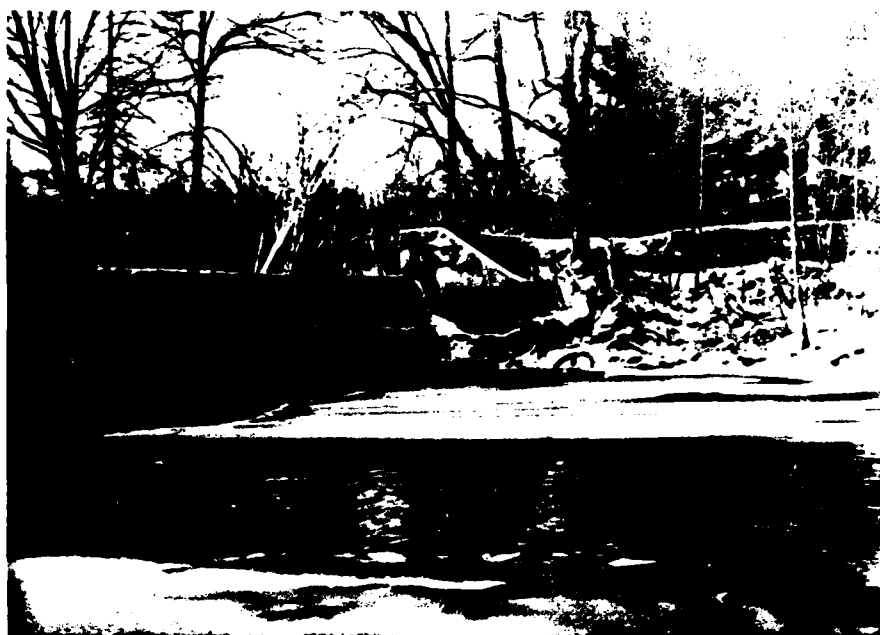
As shown in Photo 5, the concrete wingwall west of the spillway was in fair condition with no visible cracks. The bottom portion of the wingwall appeared to have been recently repaired with no apparent voids underneath; however, the north end of the wingwall did show signs of continuing deterioration (See Photo 7). At the junction of this wingwall and the west concrete dam embankment, moderate deterioration was observed as shown in Photo 6. Some efflorescence was also noted at the construction joints of the west dam embankment as shown on the general dam plan in Appendix B. The area

Photo 5 - View of spillway and west wingwall.

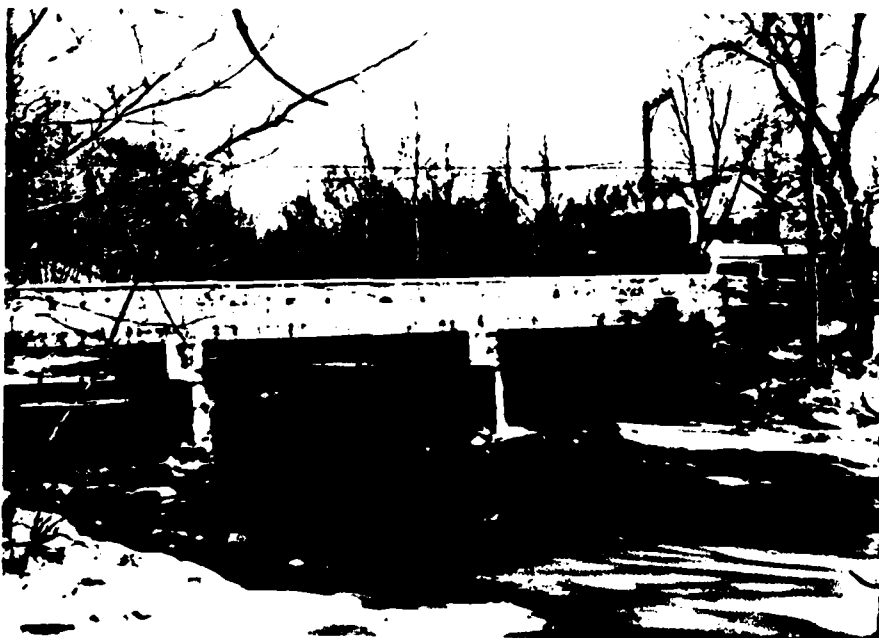
The channel downstream of the dam is a natural rocky bottom brook with several ledge outcrops along the downstream route. The general condition of the channel is very good with no accumulation of debris. Located approximately 120' downstream of the dam is a masonry and concrete bridge with a 24" cast iron sewer pipe hanging from the structure (See Photo 8).

Photo 8 - View of highway bridge and downstream channel (Stoney Brook). Note utility pipe suspended under bridge.
